44 MARKET ST – REFURBISHMENT OF A DUAL DUCT BUILDING

DR PAUL BANNISTER

ABSTRACT

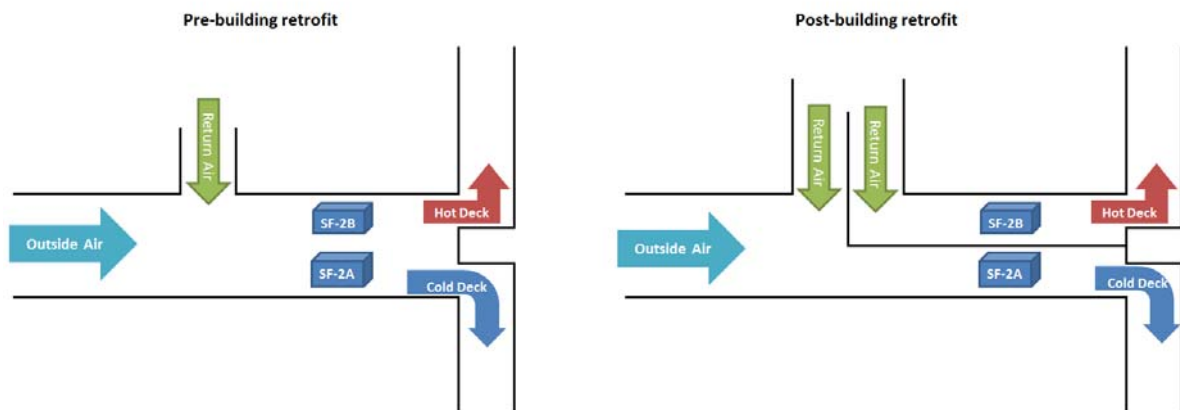
Figure 2: AHU-2 pre- and post-retrofit hardware configuration

- Air handling plant: The common supply plenum for the major air-handlers significantly limited the ability of the fans to turn down in response to load, and also meant that economy cycle operation was limited (due to the common plenum for neutral and cold decks). Furthermore, the riser dampers were not well commissioned, resulting in excessively pressures (>1000pa) at the fan outlet. AHU 5A was poorly configured, with a cooling coil followed by a hot deck and bypass deck (no cooling/heating coil) split, resulting in simultaneous heating and cooling.

- AHU-1 and AHU-2 dual duct system: A dividing wall was installed between the cold and hot deck supply air fans, effectively changing the supply air configuration from two fans operating in parallel to two independently operating fans. The economy cycle was configured to only serve the cold deck.

- Pitot flow sensors were installed in all mixing boxes, providing measurement of total airflow. This modification enables pressure independent control of both the cold and neutral fans.

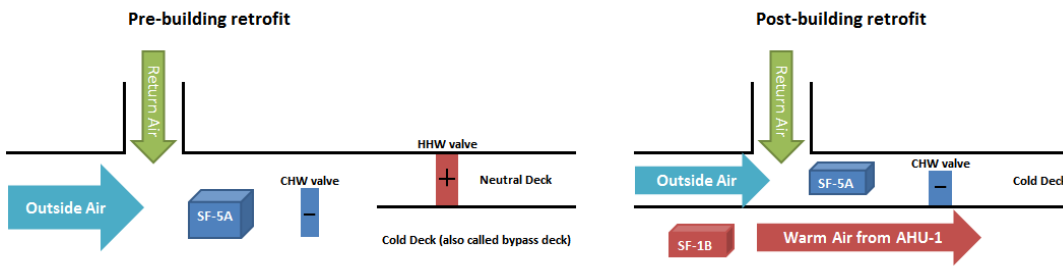
Figure 3: AHU-5A pre- and post-retrofit hardware configuration

- The dual-duct system on Level 1 (Childcare Centre) comprised of AHU-5A and AHU-5B, designed for 7,450L/s supply air. AHU-5A had its chilled water coil prior to the hot/cold deck split (see Figure 3), whereas AHU-5B had a standard dual-duct configuration with a chilled water coil in one duct, and hot water coil in the other. All mixing boxes had separately controlled neutral/cold dampers and were designed to be pressure independent (one flow sensor per mixing box).

- AHU-5 and Level 1 servicing: The reheat in AHU-5A was demolished and removed. AHU-5A now supplies cold air to Level 1 mixing boxes, with hot air supplied from low-rise AHU-1B.

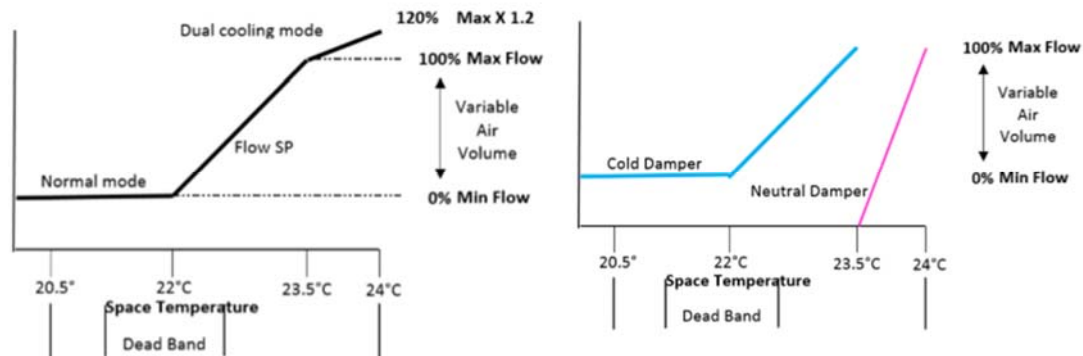
Figure 4: Terminal mixing boxes control - (Left) Air flow set point control in normal mode and dual-cooling mode. (Right) Mixing dampers operation in cooling mode.

- Terminal mixing boxes: While the mixing boxes were specified to have a pressure plate (i.e. a perforated plate across which pressure can be measured) to enable flow measurement and thus pressure independent flow, many boxes did not have these plates. This meant that the system ran as a pressure-dependent system, limiting fan turn down due to the need to maintain a fixed duct pressure; this also meant that the control of airflow in the mixing boxes was generally poor.

- Terminal mixing boxes (Figure 4 and Figure 5). Early reviews of box operation showed that while the mixing boxes were configured to

open the cold duct dampers proportionally to zone temperature, the parameters had been heavily modified over time. Under the refurbishment, the mixing box control was modified into a three stage system as follows:

- The relative position of neutral and cold duct dampers was set based on deviation from zone set-point. Under normal control, the cold damper operates from fully closed to open over the range $SP-0.5^{\circ}\text{C}$ to $SP+0.5^{\circ}\text{C}$, with the neutral duct operating to the reverse of this.
- Total flow is modulated by applying an overriding adjustment multiplier to the position of both dampers to obtain the required mixed flow. Flow increases from minimum to maximum from $SP+0.5^{\circ}\text{C}$ to $SP+1.5^{\circ}\text{C}$.
- When the neutral duct is in cooling mode and the zone temperature exceeds $SP+1.5^{\circ}\text{C}$, the neutral duct damper is opened from zero to 100% and the flow modulated from maximum to 1.2 times maximum. This combination provides variable volume control of total flow as well as

pressure independent variable volume control of the cold and neutral dampers.
